**Subject: Annual Inspection Report
Headland Municipal Airport**

ANNUAL INSPECTION REPORT

HEADLAND MUNICIPAL AIRPORT

HEADLAND, ALABAMA

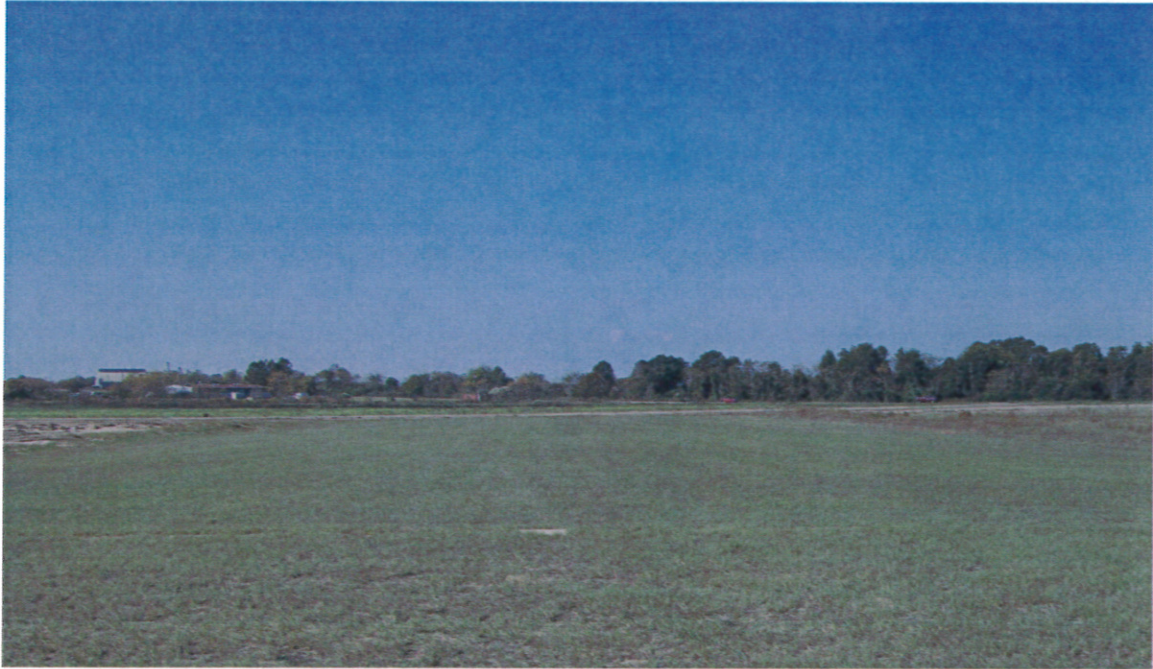
Photo # 1 – Runway 9 Approach

- Runway 9 – No Obstructions (See Photo # 1)
- Runway 27 – No Obstructions (See Photo # 2)
- Runway 17 – No Obstructions (See Photo # 3)
- Runway 35 – No Obstructions (See Photo # 4)

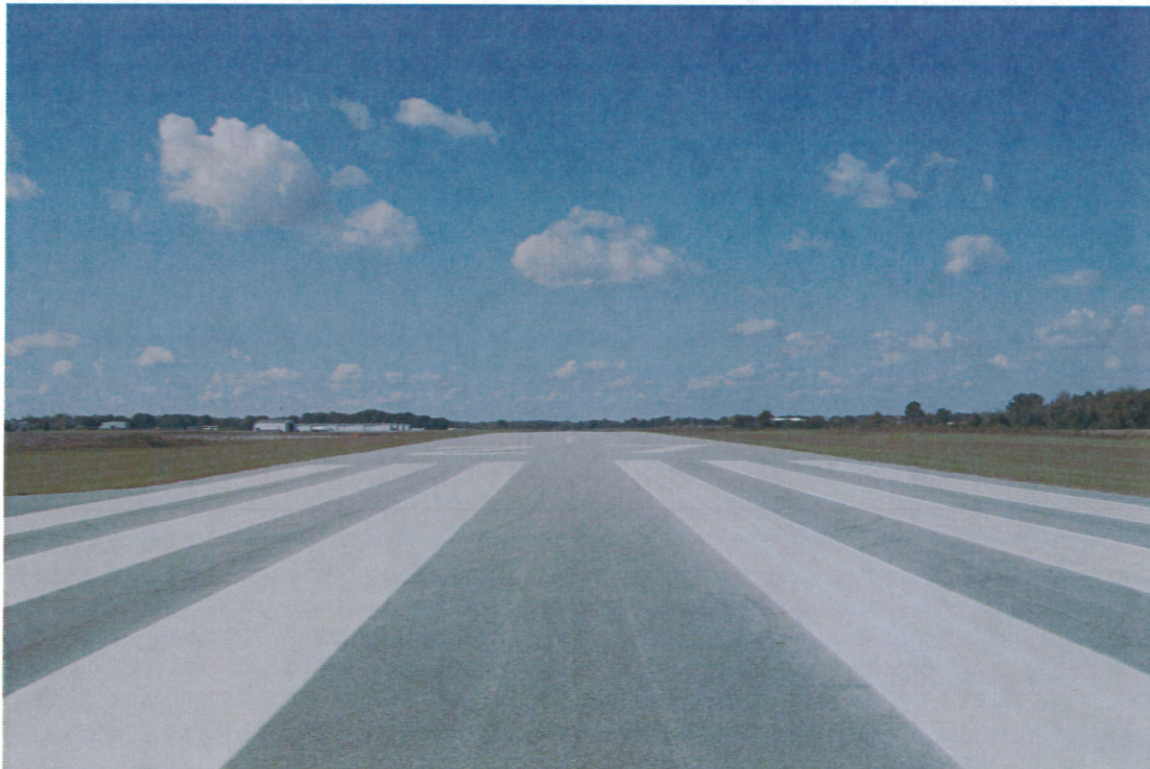
Photo # 5 – NPI Markings Rwy 27

- The paved runway markings and turf markings are in good condition (See Photo # 5).

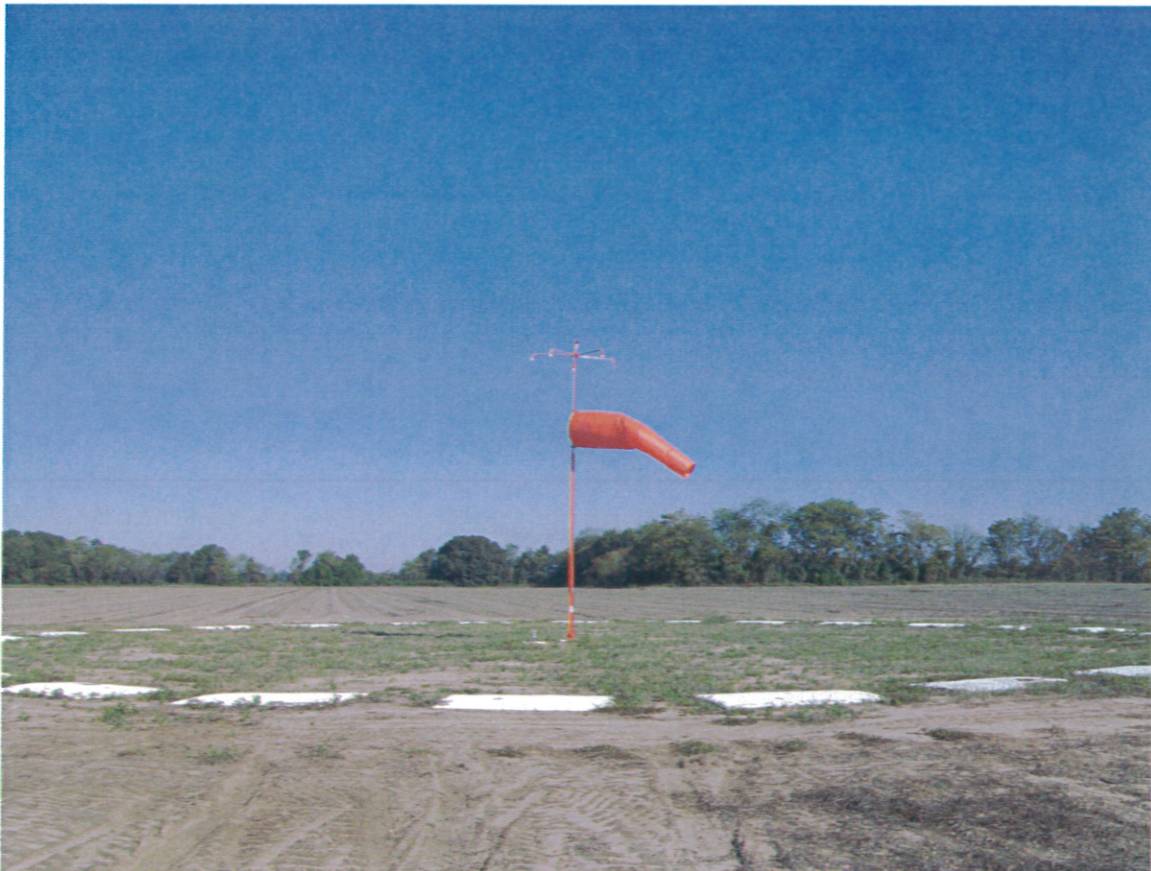
Photo # 6 – Wind Cone

- A new wind cone and segmented circle have recently been installed and are operational.

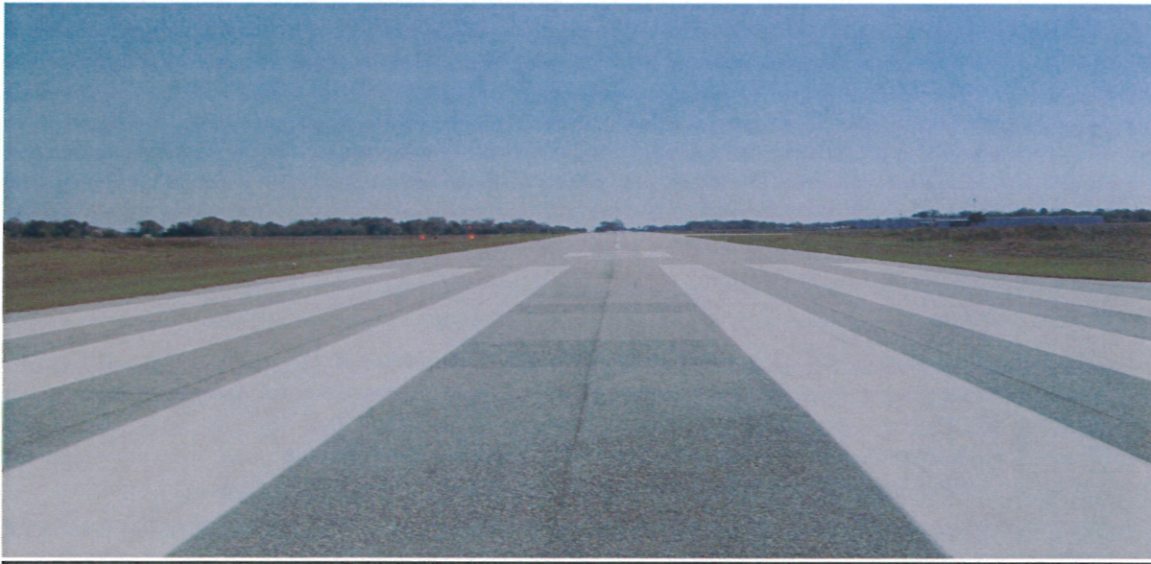
Photo # 7 – Pavement Surface

- The airport pavement surfaces as well as the turf surfaces are in excellent condition (See Photo # 7 & # 8).

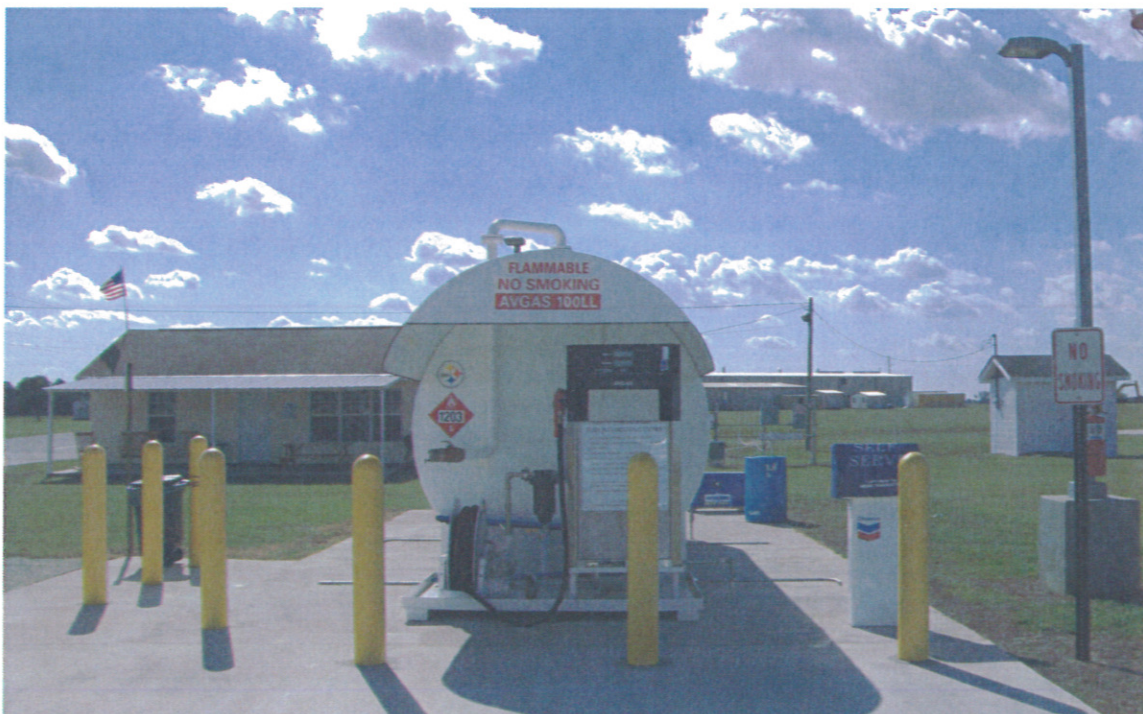
Photo # 9 – Fuel Facility

- A new AVGAS fueling system has also been recently installed and meets the requirements established by the Alabama Department of Transportation, as well as a recent inspection by the State of Alabama Department of Agriculture and Industries (See Photo # 9).
